FRONT FACADE

***Explanation of Project***

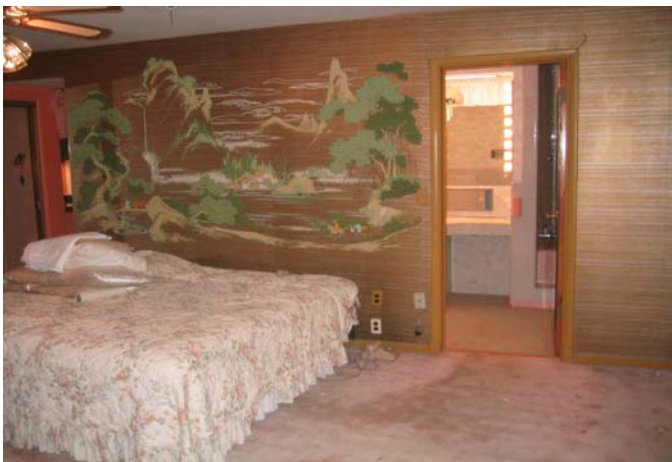
**BEFORE PICTURE 1 – View of existing Master bedroom and Master bathroom.**

- The flow of the master bedroom suite was rationalized by relocating the bathroom door. This improved the flow of the bedroom and space within the bathroom.
- A combination of settlement and poor construction required us to level several floor and ceiling areas.

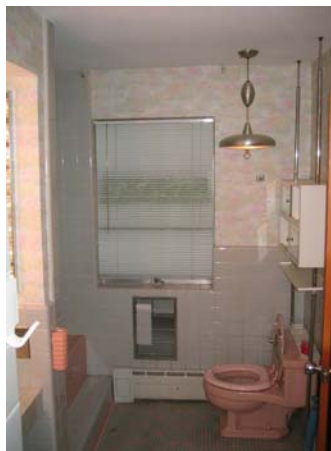
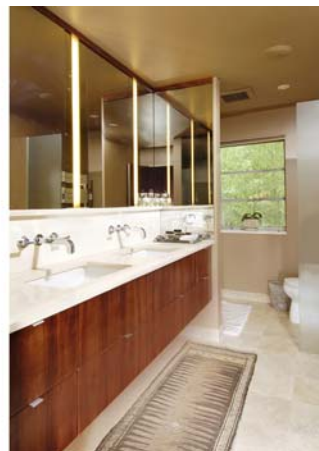
**BEFORE**

**AFTER**

- The vanity elevation in the master bathroom is a unique and challenging design. It incorporates precision flush mount medicine cabinets built into a wall of mirrors. Custom strip lights are located behind the one-way mirrors, so that when they are off you cannot see them. The precise proportions and layout of the square sinks and wall mounted faucets with the custom vanities below required a full mock up before final proportions were approved (See before & after pictures below).

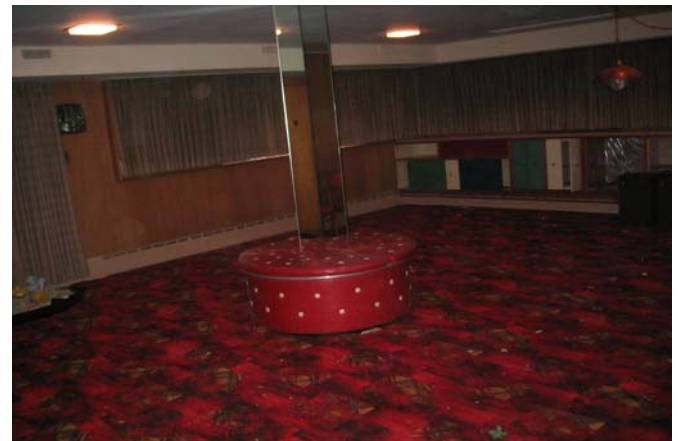
**BEFORE PICTURE – Basement recreation room.**

We maximized insulation in the walls as framing allowed. We reworked/repared ventilation and cooling ductwork as needed. Another challenge was replacing the existing paneling with drywall such that no window casing would be required. Wood windowsills were installed for durability (*See after picture below*).

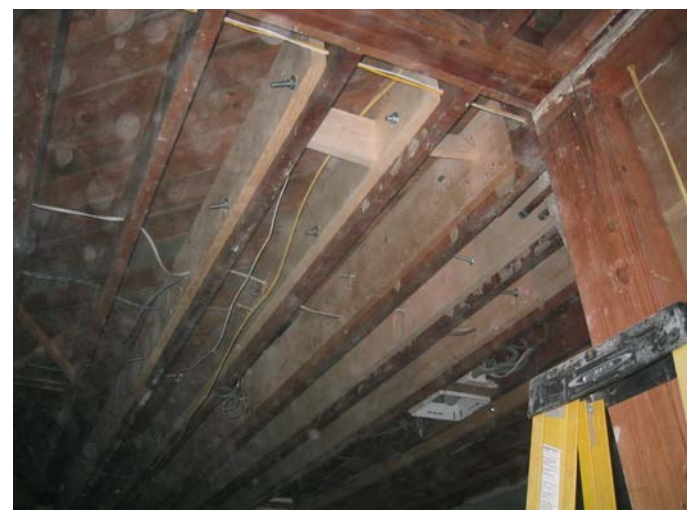
**DURING PICTURE – Sister joists below Master bathroom.**

After opening up all walls and the ceiling we discovered extensive termite damage and structural insufficiencies. Substantial reframing was required. Structural work included adding double glue lamb beams to eliminate a mid span column and sistering all the joists in the ceiling below the master bathroom (*See before & during picture above*).
