Explanation of Scope of Work

We worked with a designer to renovate the kitchen in this handsome English style stone home. The existing kitchen was a 70's remodel and had to be replaced due to a small fire behind the wall oven. The project included extensive electrical, plumbing and ventilation work (*See before picture – upper right*).

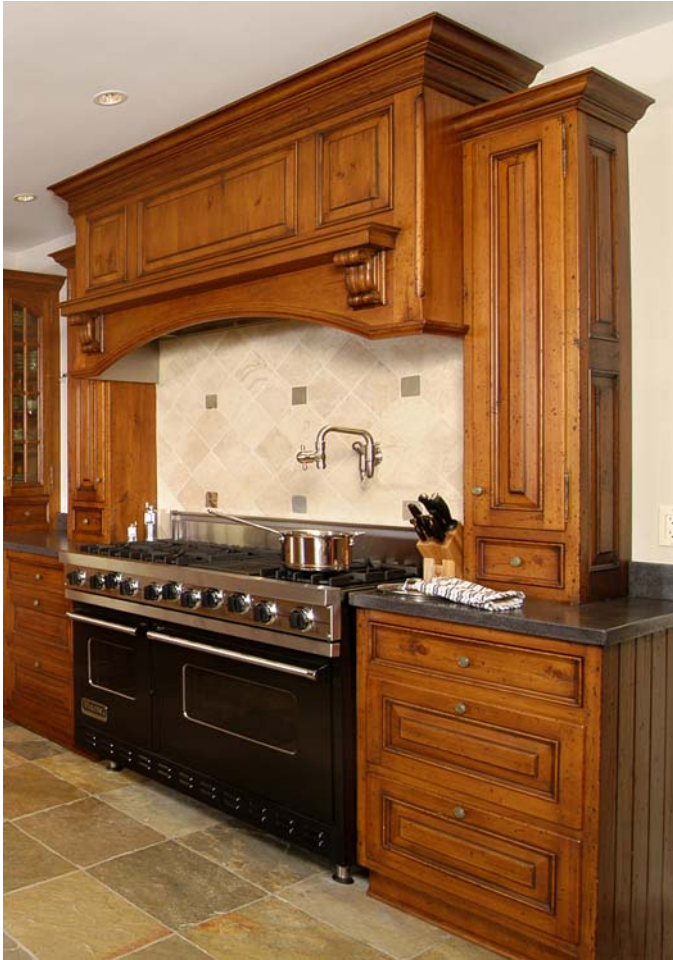
AFTER PICTURE – VIEW OF COOK RANGE

Contributing to the old world style of the project are appliance cabinet panels that disguise all of the high-end appliances, except the 48" range.

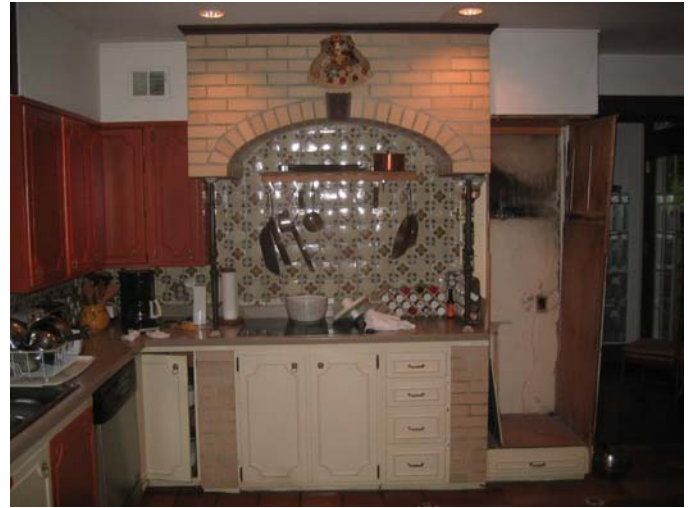
BEFORE PICTURE – View Of Existing Kitchen.

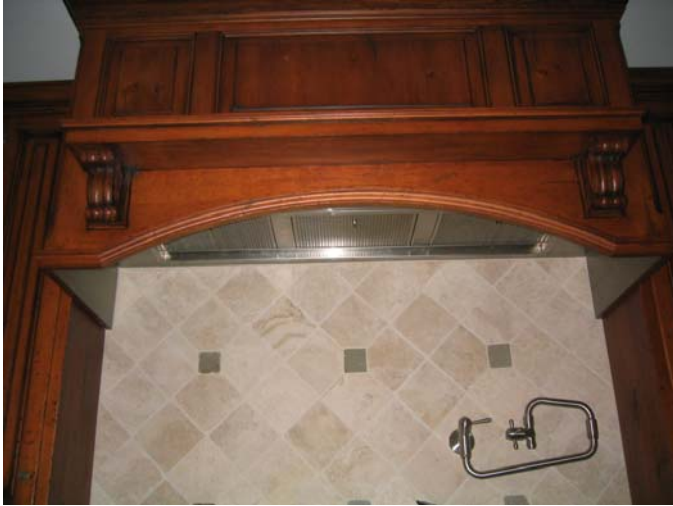
AFTER PICTURE – View Of Exhaust Vent Above Cook Range.

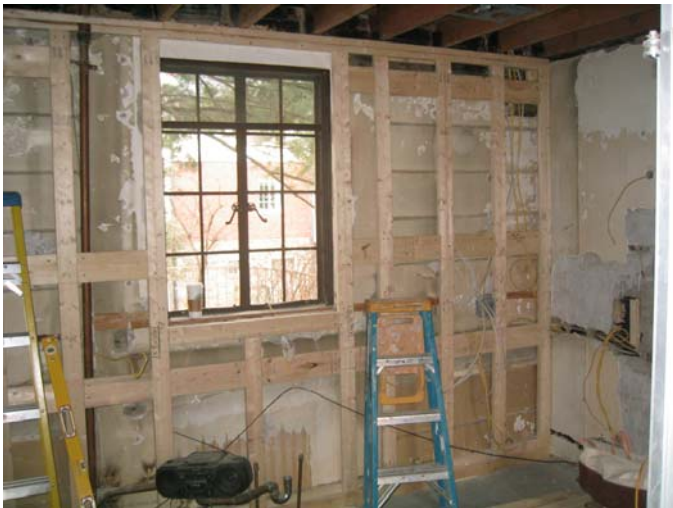
DURING PICTURE – View Of Casement Window Above Sink During Construction.

the new pot filler. We then carefully skimmed it with concrete and laminated it with plywood to make it level and strong. The old metal casement windows are tied into the kitchen with tile work that flows into the back splash. The windows, along with their original role screens, were restored and painted.

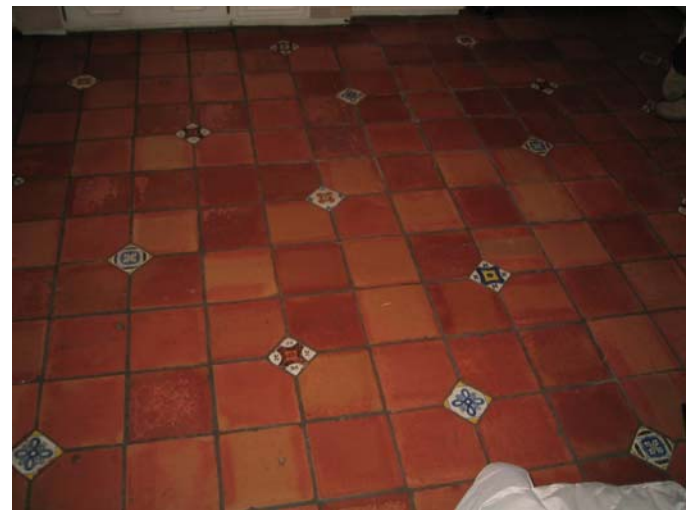
BEFORE PICTURE – View Of Existing Floor Tiling.

The existing tile floor had cracks running through it (*See before picture - right*). We replaced the existing sleepers and sub floor in order to ensure this wouldn't happen again (knowing we would be installing a 48" Viking range and a Sub-Zero refrigerator also motivated us to make the floor really strong). The new tile floor also incorporates an electric warm tile heating system. There are no more cold spots in the kitchen.

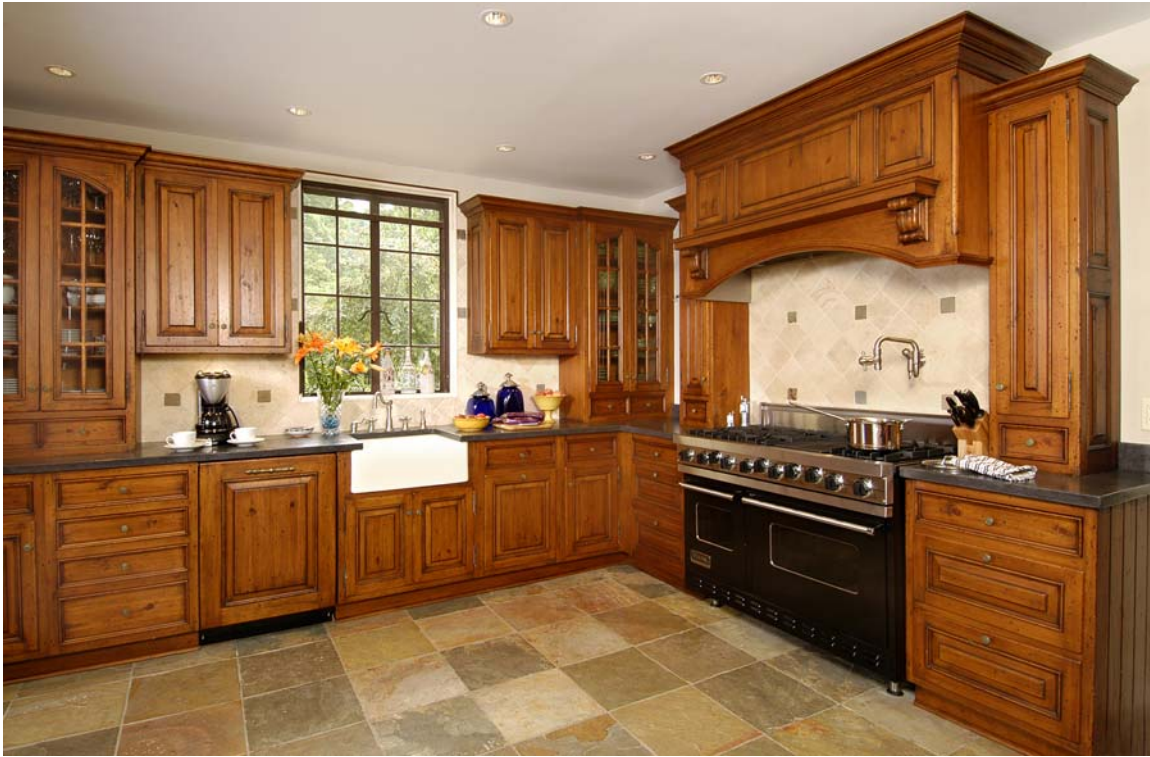
AFTER – Overall View of Kitchen Area

The homeowners are very happy with their kitchen and the high level of craftsmanship that went into every surface. The finished kitchen exudes old world warmth while providing all of the modern comfort the homeowners wanted, along with a few bells and whistles.
