Unusual Challenges/Constraints and Creative Solutions

Explanation of the Scope of Work

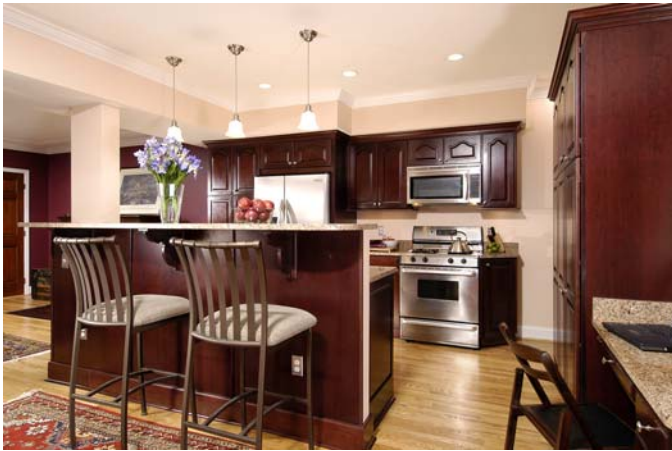
PICTURE 1 - AFTER – HIGH BAR AREA

The essential needs of the client included opening up the space to combine the kitchen, dining room and living room areas. The high bar area was designed to conceal the kitchen clutter (*See picture 1 - upper left corner*). The finished side and end panels have a furniture quality, making the kitchen blend in artfully. Also important was that he needed to stay within the budget he had set. We were conscientious of the customer’s budget through the entire design/build process.

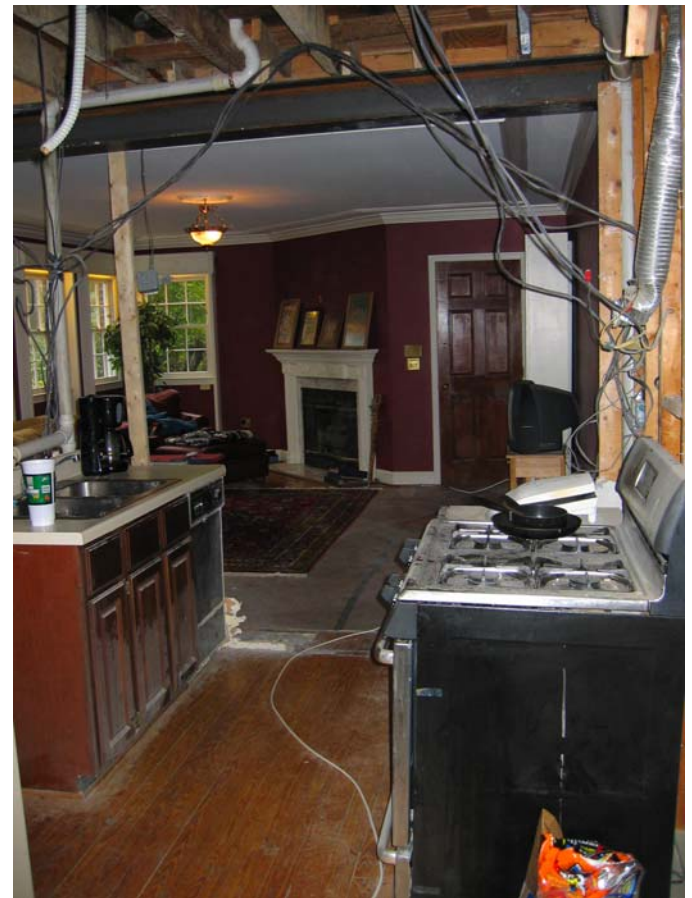
BEFORE PICTURE – View of exposed steel beam, joists & plumbing lines left unfinished by previous contractor.

The previous contractor left us with structural challenges. He had installed a steel beam in order to remove an existing bearing wall between

the living room and kitchen (*See before previous page*).

However, he left it precariously supported on a couple of temporary columns. An adjacent girder had also been compromised when it was notched with a reciprocating saw. We found it supported by a single bowed 2"x4". After much discussion, we determined that we needed to install a mid span column to ensure the structural integrity of the house.

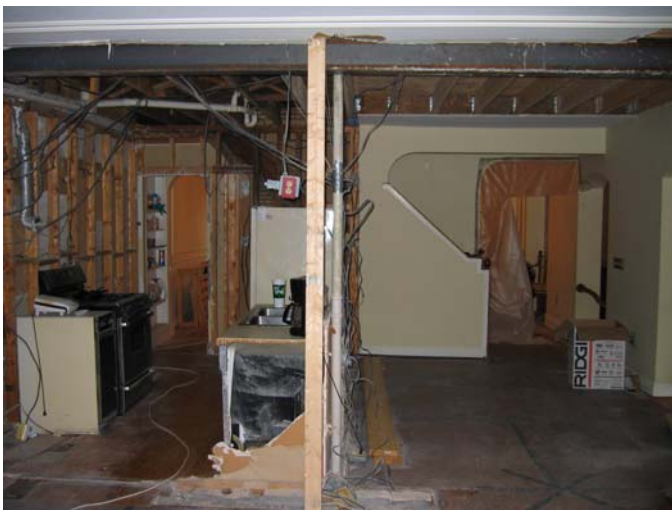
This client contacted us after his unlicensed, uninsured contractor disappeared with the homeowner’s generous deposit. The contractor had completed most of the demolition but left the work areas a real mess. There were not even any drawings or other construction documents when we took over (*See picture below*). For this entry our scope was the eat-in kitchen area. However, we did a good deal of work in the rest of the house as well.

BEFORE PICTURE – Existing kitchen conditions after demolition by previous contractor.

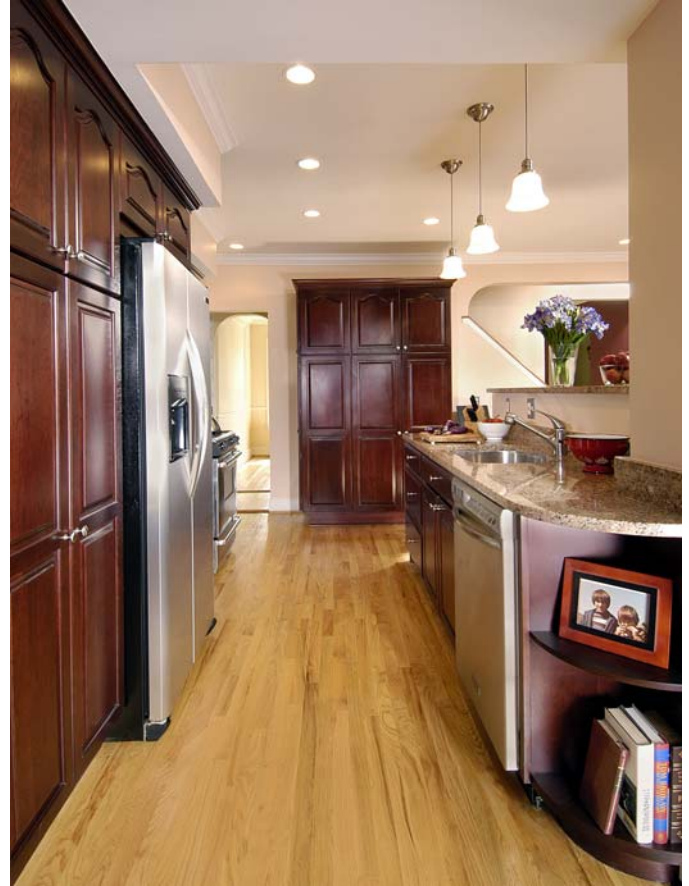
We laid out the kitchen in a galley format to maximize the living space. Given the open nature of the kitchen design, cabinet space was maximized by using three full height pantries. There are four distinct counter areas including a desk. Bulkheads above the cabinets and one column conceal plumbing, ductwork and structural steel. We softened the look of the bulkheads by using crown molding on all ceilings. New oak wood floors were feathered into existing ones and the entire area refinished (*See after picture right*).

AFTER PICTURE – View of full height pantries & wood flooring.
