***Explanation of Project***

These repeat customers wanted a wheelchair accessible space for their mother’s home in Kensington, Maryland. They wanted a handicapped bathroom and a wheelchair ramp to the front of the house. It was important that the bathroom was finished nicely, but of primary importance was that everything was functional and provided safety. They also wanted to keep within their original budget of \$55,000.

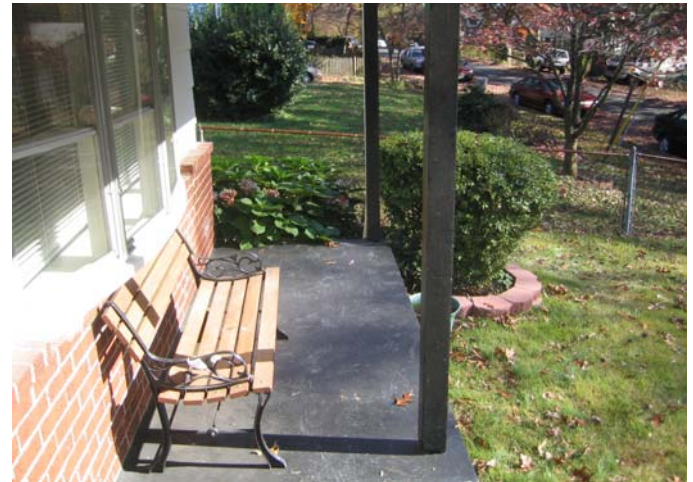
BEFORE PICTURE 1 – View Of Front Porch.

Their front yard is steeper than it looks and required several design iterations. We agreed on a plan that incorporates a wood ramp with safety railing that gradually slopes across the front yard to a landing and concrete walkway. We struggled with the design of the ramp so that we didn’t cut up the yard too badly. During this project we learned the precise distinctions between residential, commercial and assisted access incline codes (*See before & during pictures on the right*).

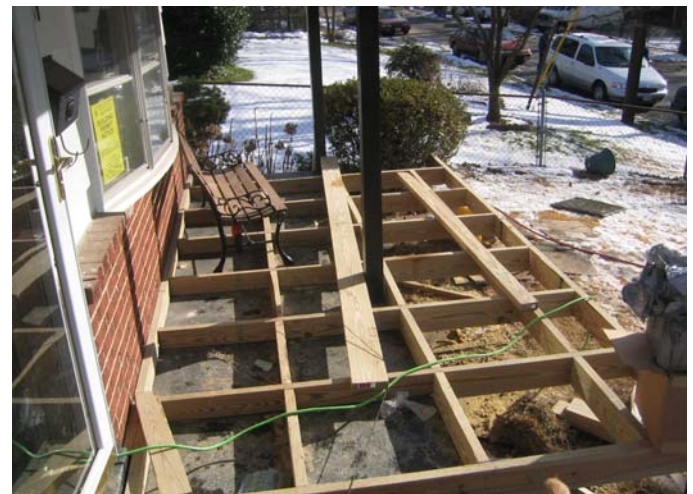
DURING PICTURE 2 – View Of Front Porch framing.

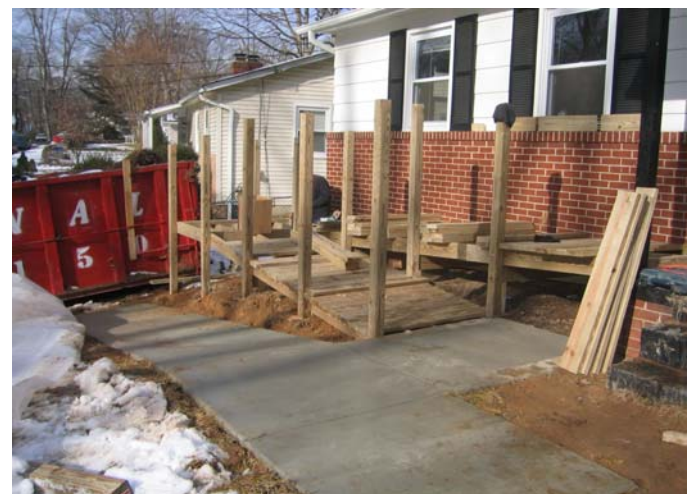
DURING PICTURE – View Of Ramp.

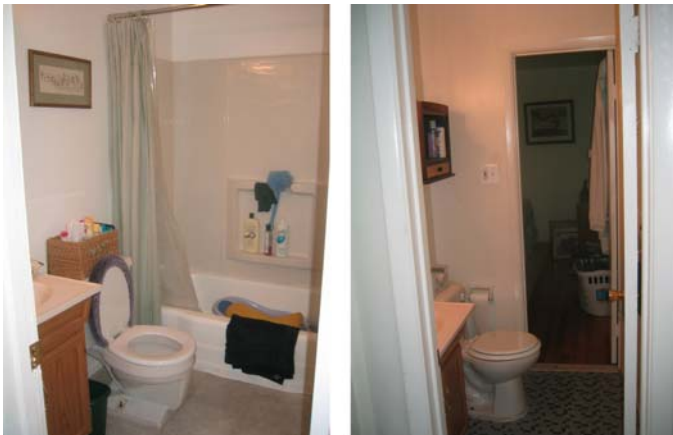
**BEFORE PICTURE – View Of ½ & Full Size Bathrooms To Be Combined.**

For the Universal access bathroom we combined a ½ bath and a full bathroom to provide adequate space for a wheelchair to maneuver (*See before picture & floor plans below*). The door was enlarged to 36” and an ADA toilet with grab bars and an ADA roll up sink complete the space. The shower was particularly challenging. Because of wheelchair access, it couldn’t have a curb top. A modest slope to the drain helped solve this problem. A double swinging custom glass shower door with fixed panel and grab bars kept water from pouring out of the shower while allowing wheelchair access and higher style than a simple shower curtain. Several grab bars around the shower provide an additional safety element. Good lighting and an exhaust fan with a heat lamp illuminate all of the very nice ceramic tile work in the bathroom.

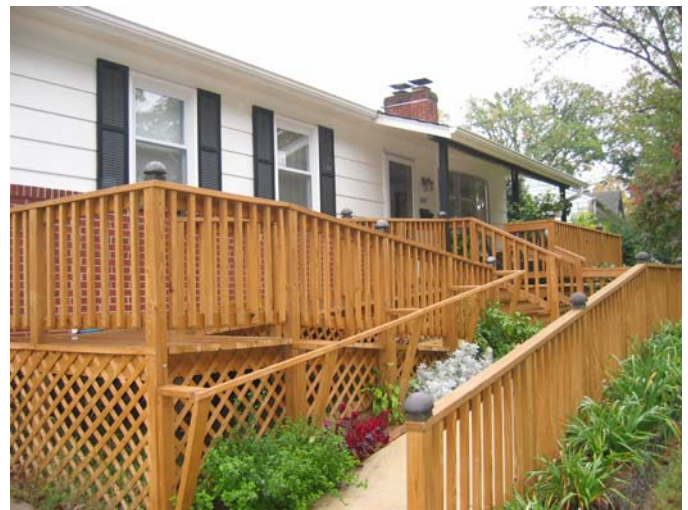
**AFTER PICTURE - Exterior view of accessible ramp.**

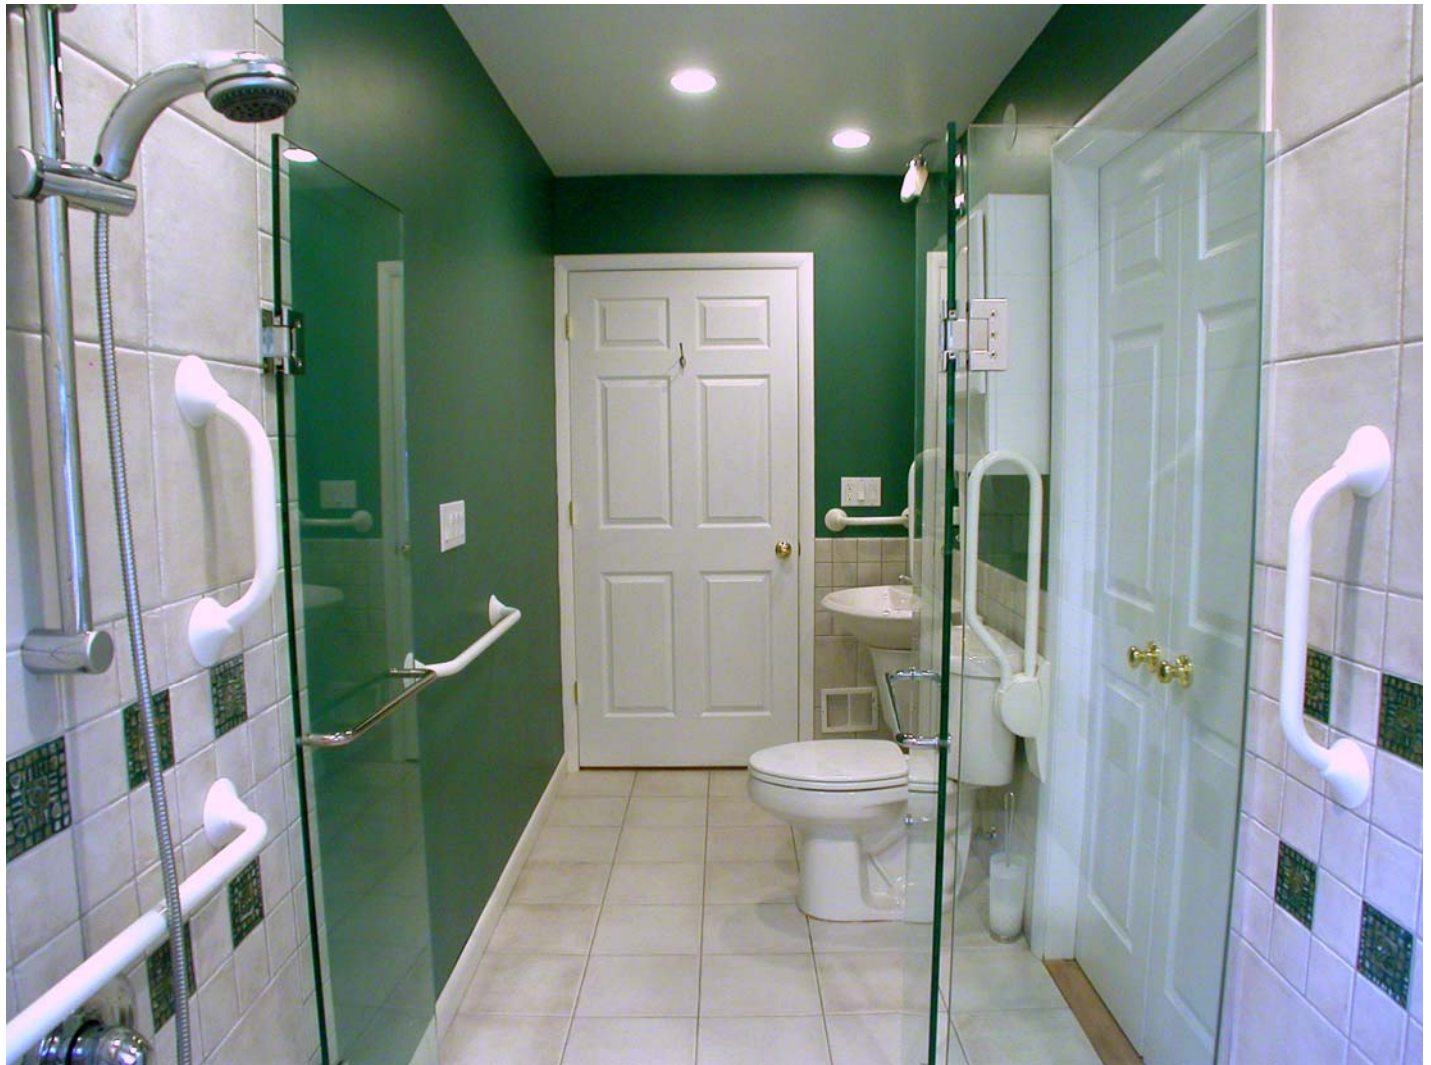
**AFTER PICTURE - Interior view of shower's grab bars.**
