FRONT FACADE

***Explanation of Project***

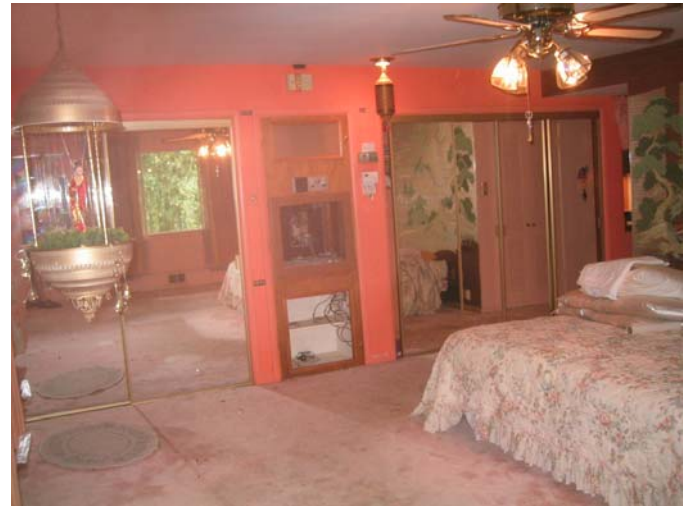
**BEFORE PICTURE 2 – View of existing closets at Master bedroom.**

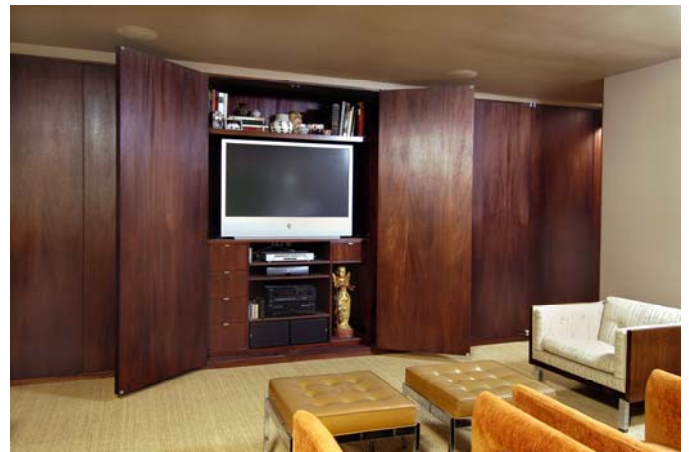
**AFTER PICTURE – View of new closets an entertainment center.**

- The flow of the master bedroom suite was rationalized by relocating the bathroom door. This improved the flow of the bedroom and space within the bathroom.
- A combination of settlement and poor construction required us to level several floor and ceiling areas.

- Customers had a very specific look they wanted to achieve. They had a number of dark mahogany furnishings and wanted to design a clean, contemporary look. We custom designed and fabricated an entire wall of flush mahogany 8'-0" closet doors with Rixon offset pivot hinges. This wall conceals closet space and an entertainment center. This look is carried around through the entry hall and into the bathroom. Note the book-matched grain on the mahogany door elements. (See after picture 1).

- Lighting in this area was improved by installing switched outlets on either side of the bed, several low voltage recessed lights and strip lights in the closets controlled by jamb switches.

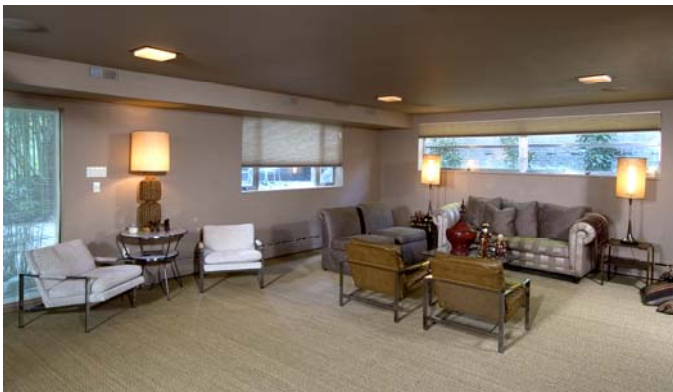
**AFTER PICTURE – New basement recreation room.**

We maximized insulation in the walls as framing allowed. We reworked/repared ventilation and cooling ductwork as needed. Another challenge was replacing the existing paneling with drywall such that no window casing would be required. Wood windowsills were installed for durability (*See after picture below*).

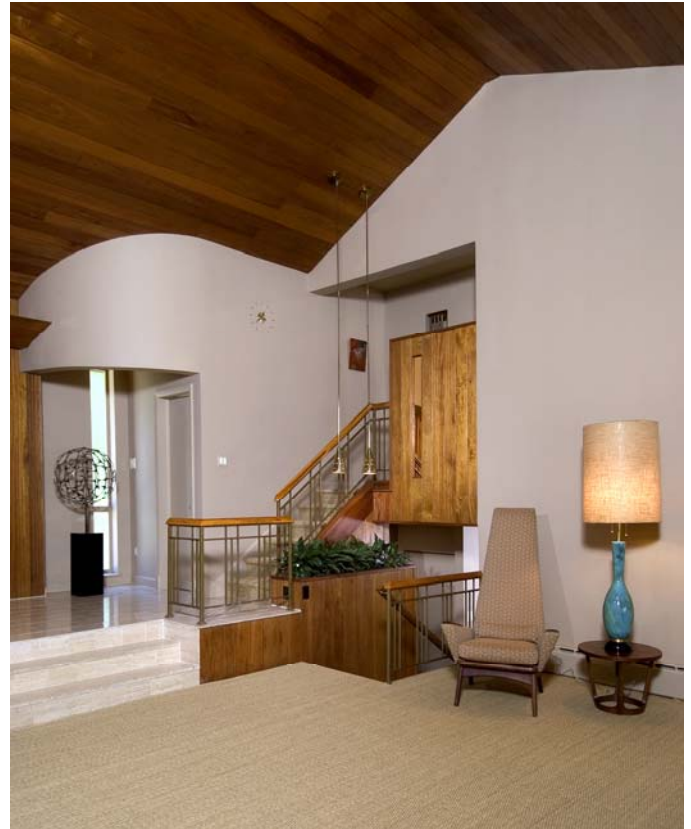
**AFTER PICTURE – Living Room - View of main hall & stairs to 2<sup>nd</sup> floor and basement.**

- Installed low voltage lighting and raised ceiling.
- Steel fitch plates at the 1<sup>st</sup> and 2<sup>nd</sup> floor stairs headers.

- Raised and leveled 2<sup>nd</sup> floor hall ceiling from 7' to 8'.
